RE: Shoreline Erosion Control and Protection at Torch Lake Yacht Club

Factors Contributing to Shoreline Erosion

Potential Engineering Solutions

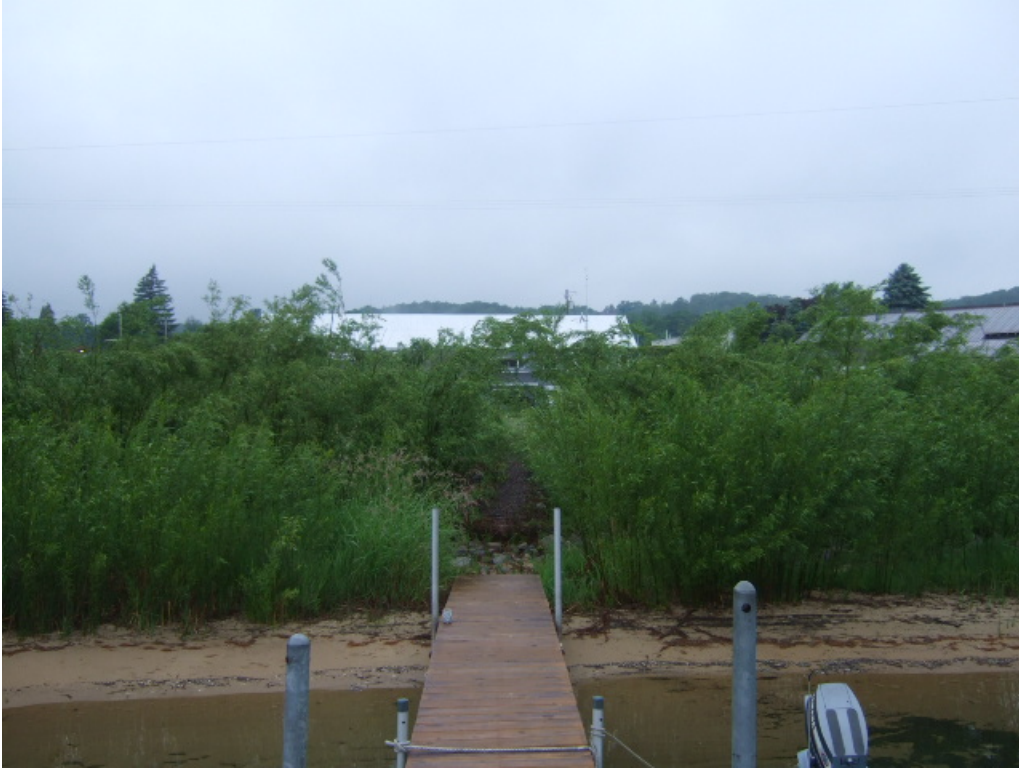
Photograph 1: Example of natural vegetation and stone shoreline protection. Vegetation holds shoreline in place in conjunction with coconut coir log and natural stone rip rap. After two to three years of growth rip rap and coconut coir log are not visible. View sheds are not maintained.

To mitigate shoreline erosion and reduce lateral transport of lake bottom sediments a combination of natural stone and vegetation is proposed for portions of the shoreline where shrubs and trees will be tolerated and direct access to the beach is not needed (Photograph 1). Where access to the beach or maintenance of a view shed is desired a natural stone or engineered block solution is proposed (Photograph 2 and 3, respectively). Photograph 4 shows a solution that includes riprap and coconut coir roll immediately after construction and before planting of vegetation has occurred. It should be noted that the "natural stone and vegetation" approach is similar to what the TLYC attempted last season. Based on observations at the site it is likely that the earlier attempt to control the bank failed due to design and construction limitations. Likely causes of failure are lack of stone, lack of filter fabric, poor soil compaction or lack of good backfill material.

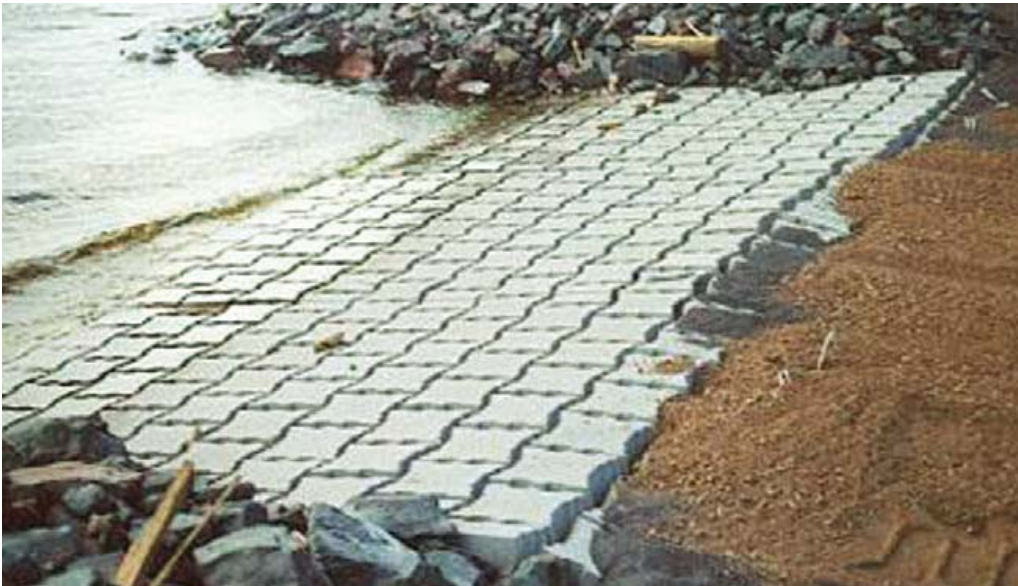
Photograph 2: Example of hard armoring of beach access location. This approach is suitable for areas that receive significant use from foot traffic and/ or launching small water craft. Size of access point can be tailored to specific use and need and incorporated into a more natural shoreline design. Alternatively, the block pavers in the photograph above can be replaced with large flat landscaping rock.

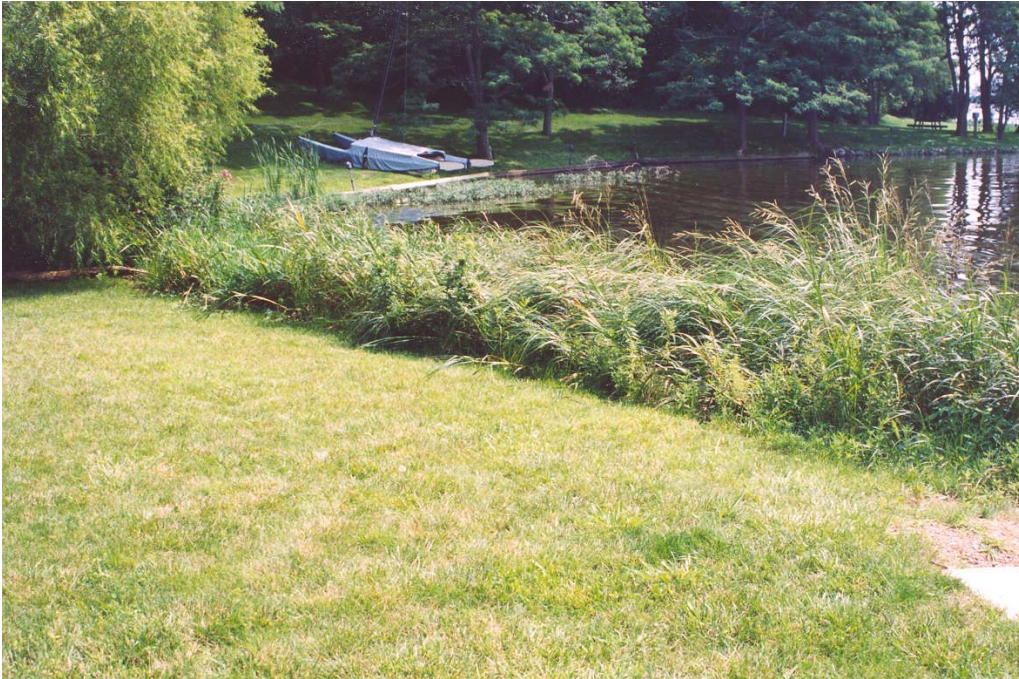
Photograph 3: Example of natural stone and vegetative armoring where views are maintained and tall vegetation is limited.

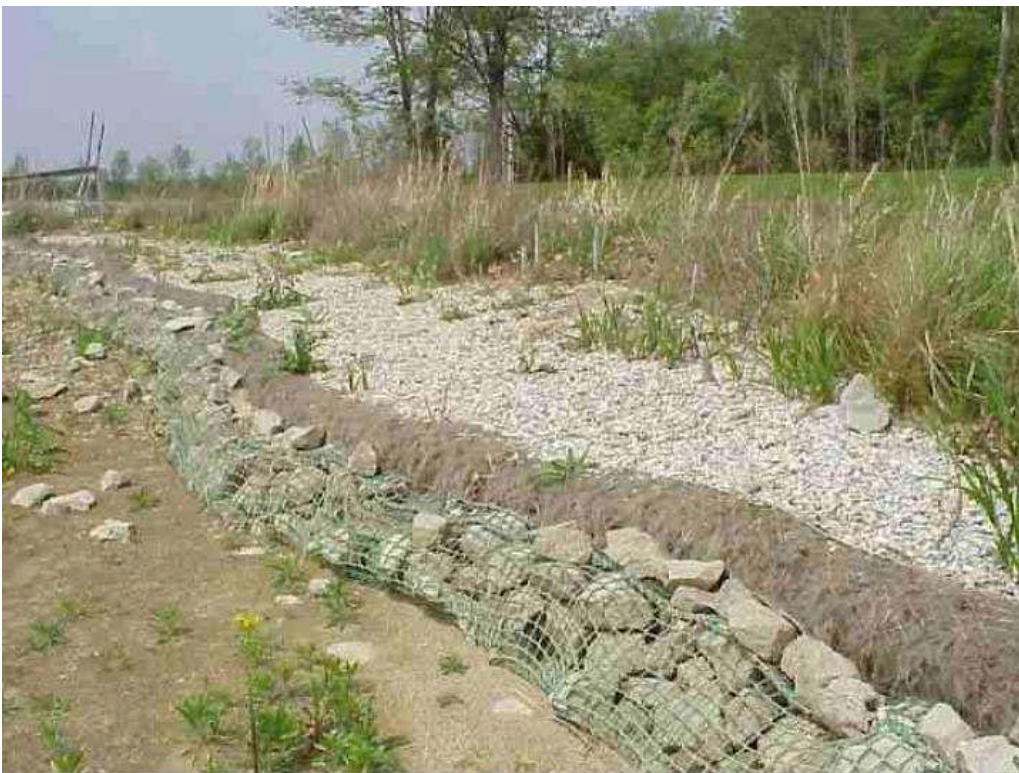
Photograph 4. Construction phase example of erosion control system that includes coir logs, riprap and vegetation.
